**HOME
EVALUATION
SERVICES**

Home Inspection Report

Sample Report

Inspected on Thu, Sep 3 2020 at 2:00 PM

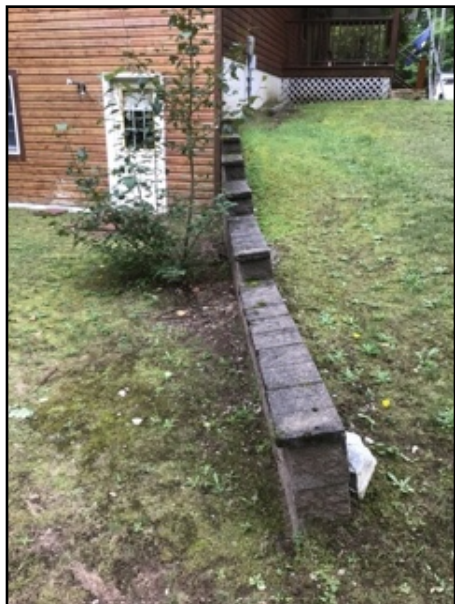
Figure 1-1

The front retaining wall is leaning from water pressure (roof runoff) this will need to be addressed at some point,.

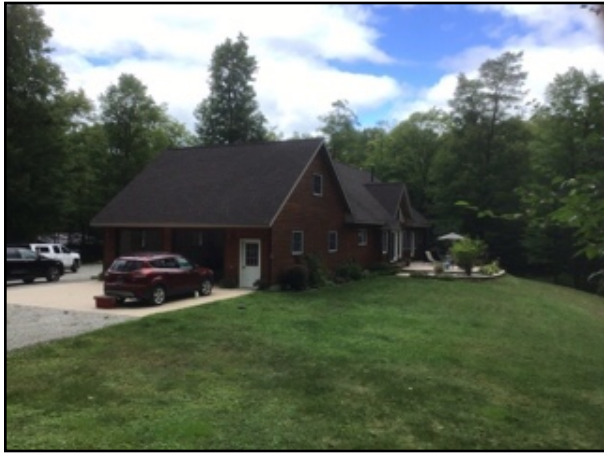
Figure 2-1

Comment 2:
Site overview. Property grounds were well kept,

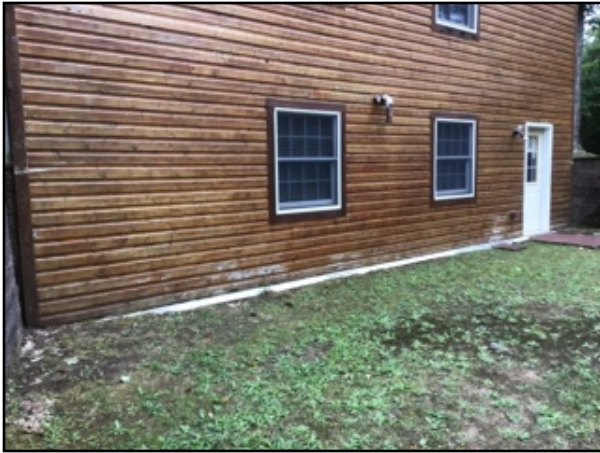
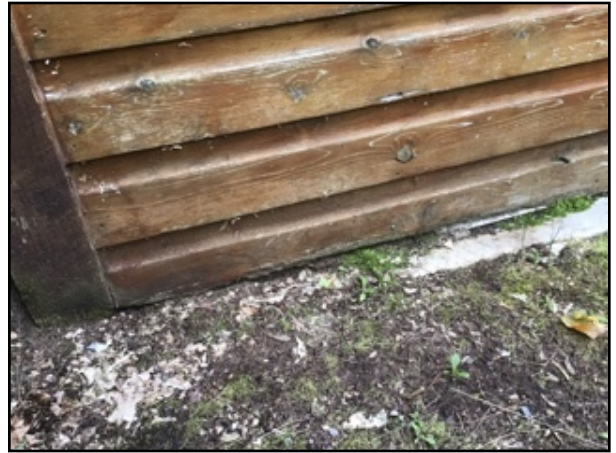
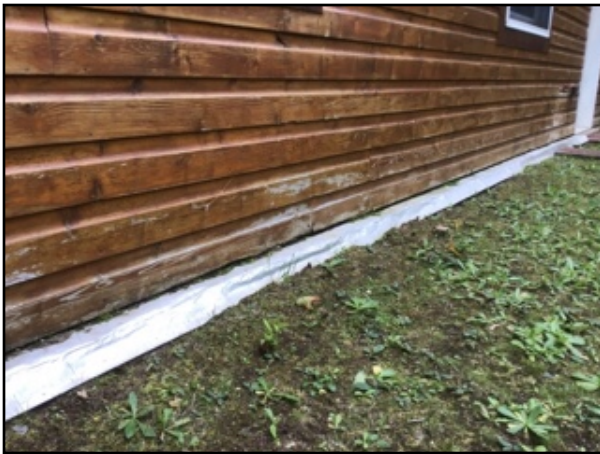
Comment 3:
The base of the siding on the East wall has some minor deterioration, this will need to be watched,

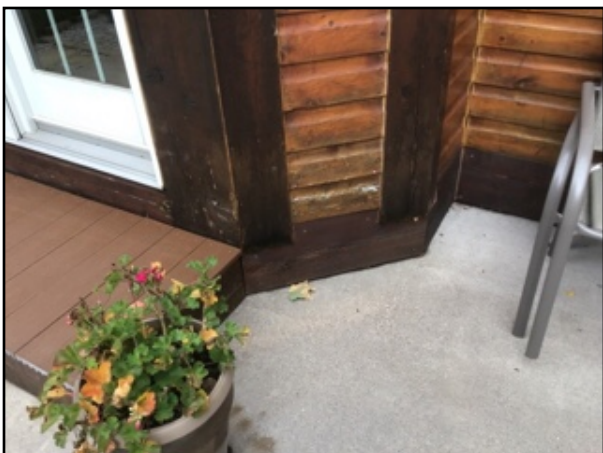
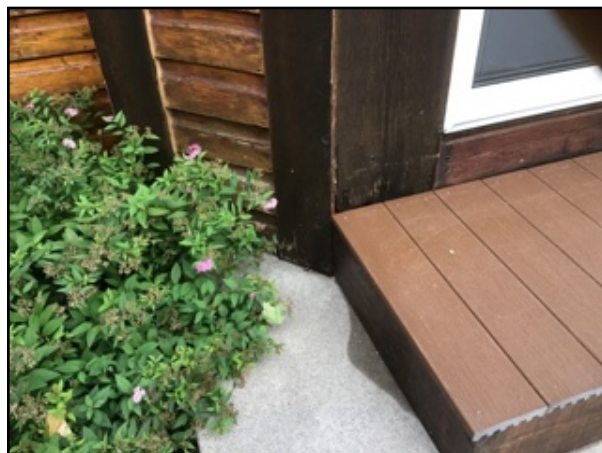
Also water splash from roof runoff is causing some water damage and deterioration along the back of the house along the base, (gutter system would prevent this).

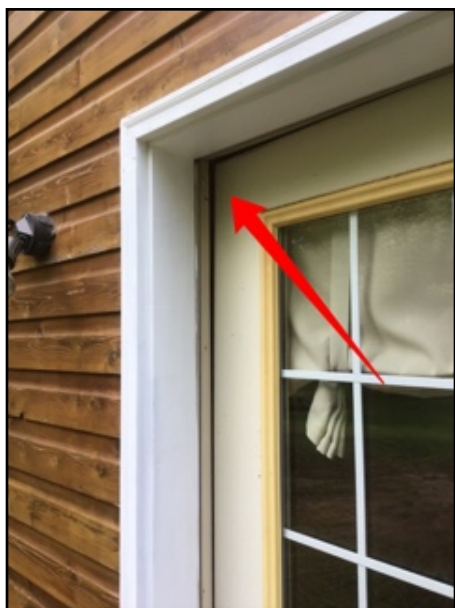
Figure 5-1

The basement entry door is warped causing poor sealing, this door will need replacement to remedy this,.

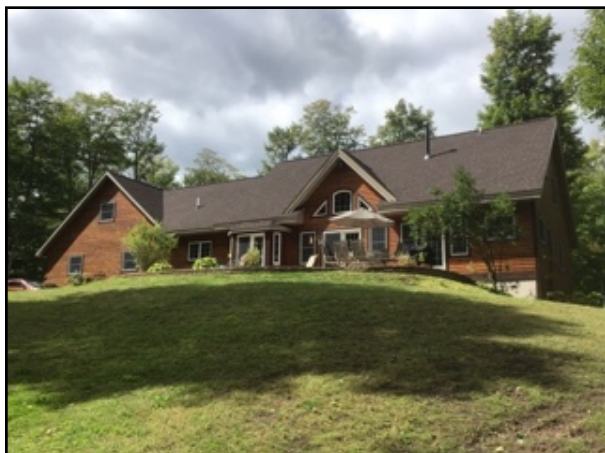
Figure 6-1

Overall the exterior of the home and garage are in good general condition, see a couple of notes in this section for areas that will need attention soon,.

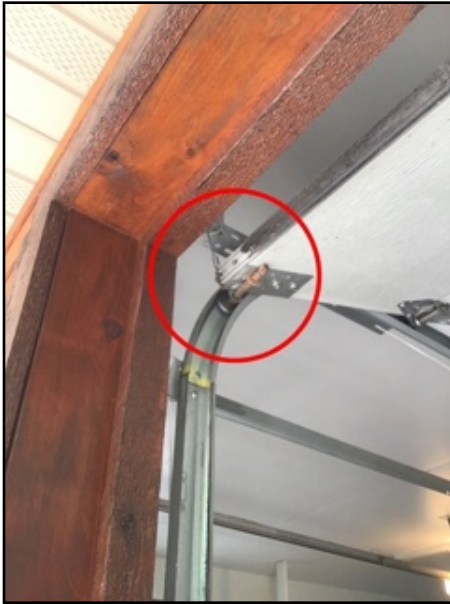
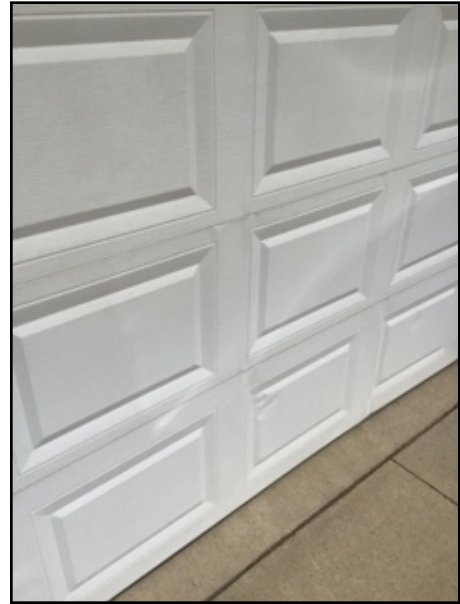
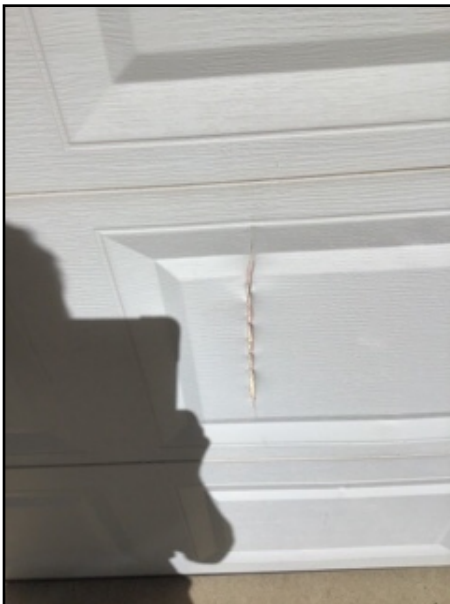
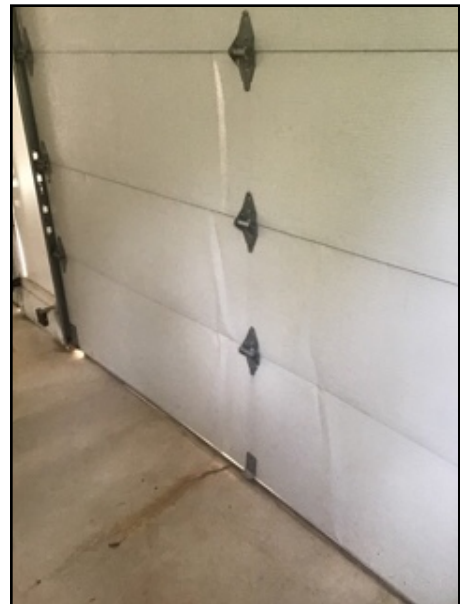
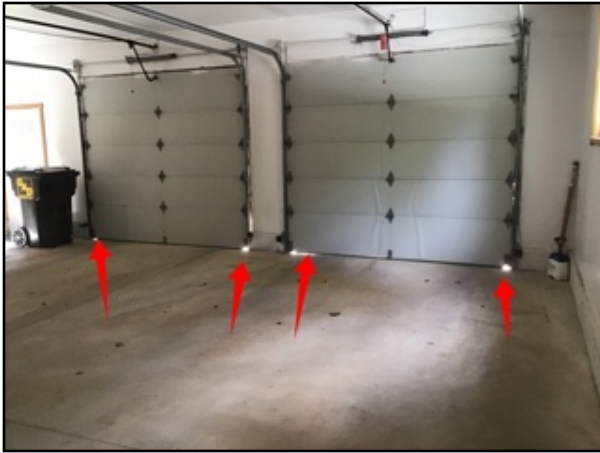
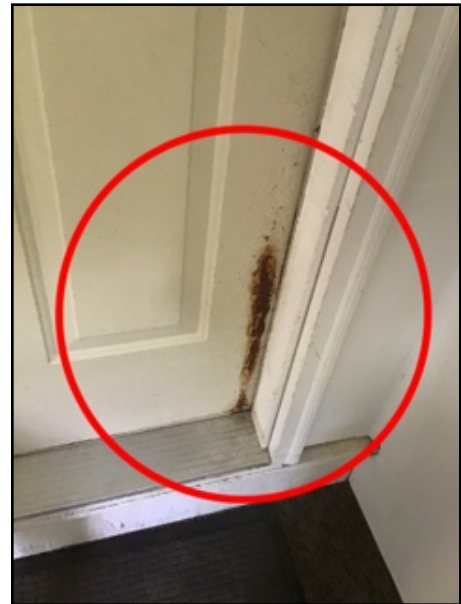
The garage door seal is damaged. (at both doors) These can be replaced. Also both doors do have some damage, noted in the photos, this damage is not effecting the operation, also the garage entry door has some pet damage , this can be repaired by sanding and re painting

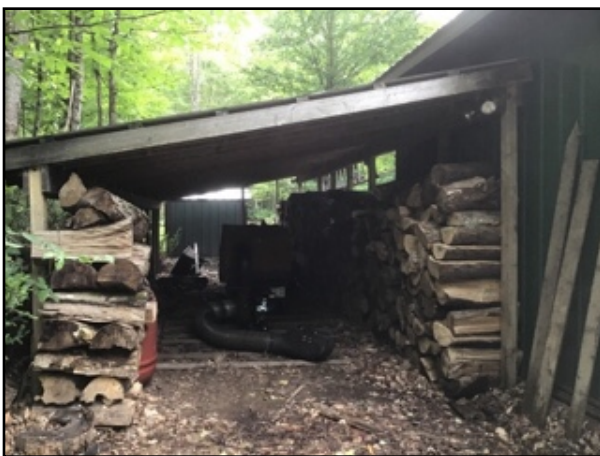
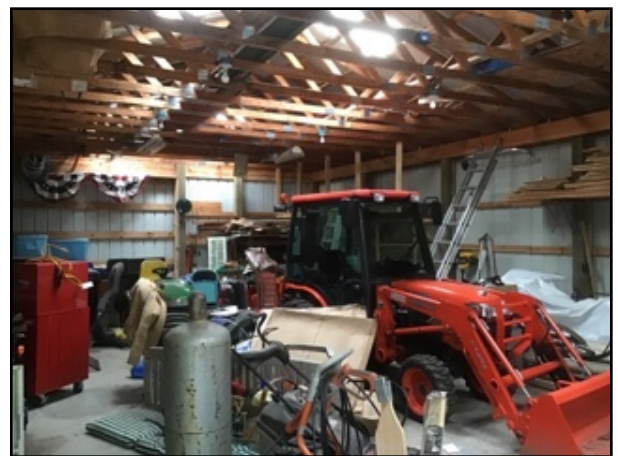
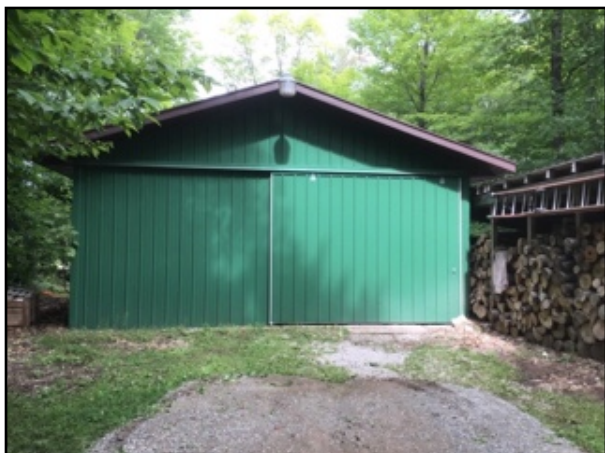
The pole barn building and wood shed structure were found to be in good general condition .

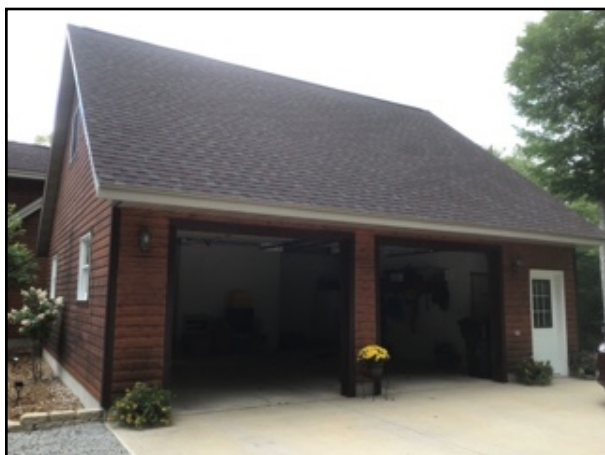
Figure 9-1

The house garage was in good general condition, some loose drywall tape at the ceiling, but overall in good condition, the attic storage area was well built, (some electrical is not completed).

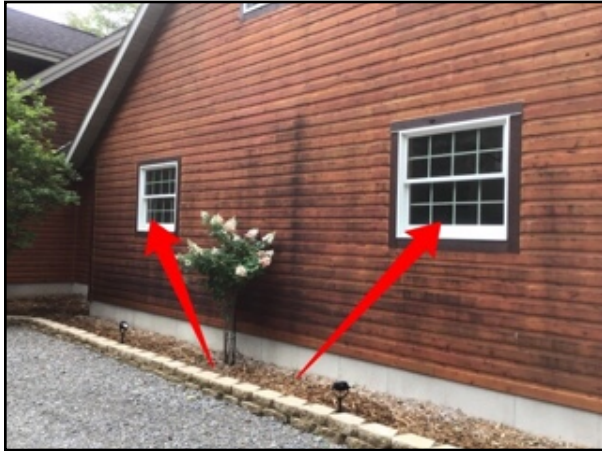
Figure 10-1

North side garage windows were missing the screens, ask about this? (one was found in the storage area).

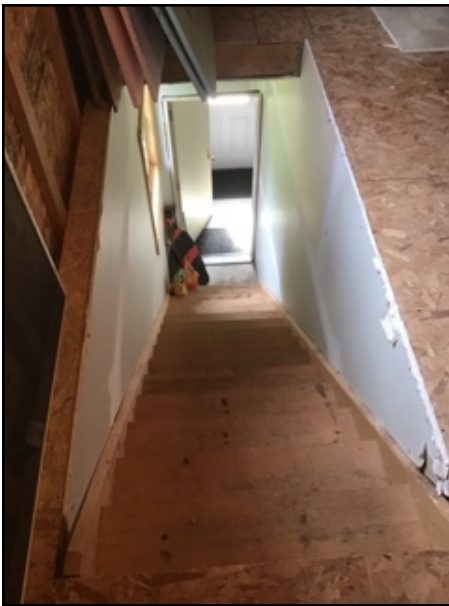
Figure 11-1

Safety hand railings are recommended at all stairways with 3 treads or more, also your insurance providers may require them. this safety item was missing at the garage stairway,

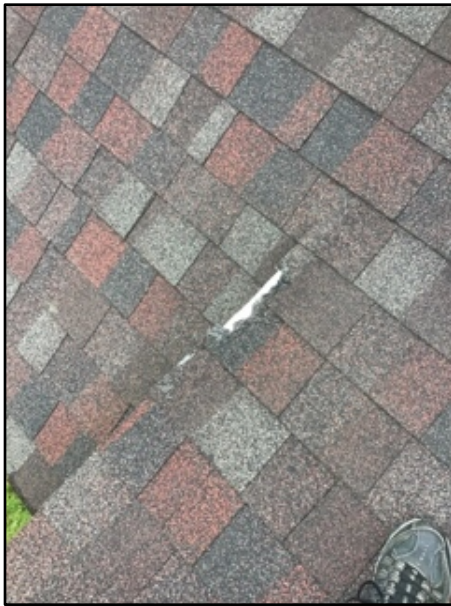
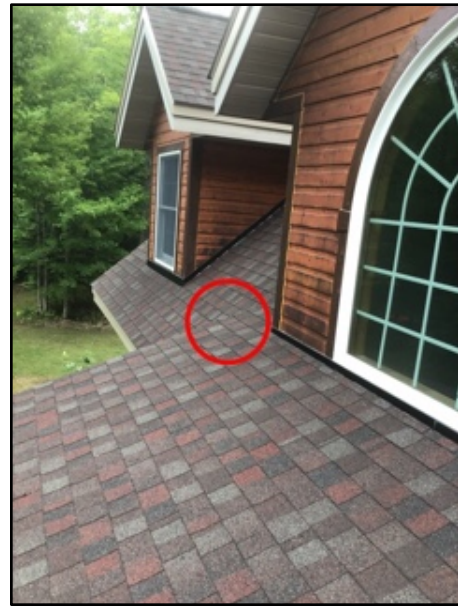
One edge section of the front porch roof had some minor damage, (appears to be from snow removal , photo 2 shows location, (noted , but repair is not needed at this time).

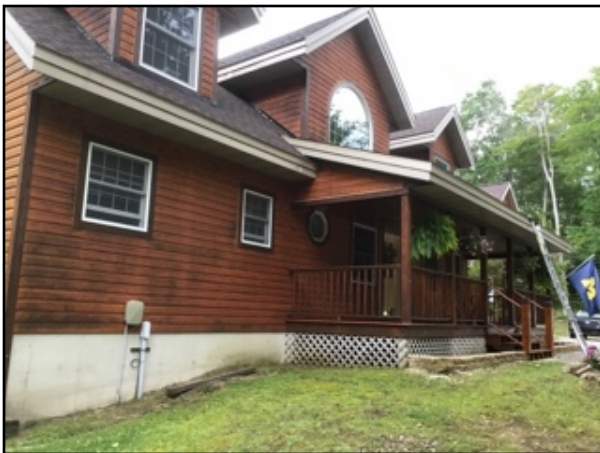
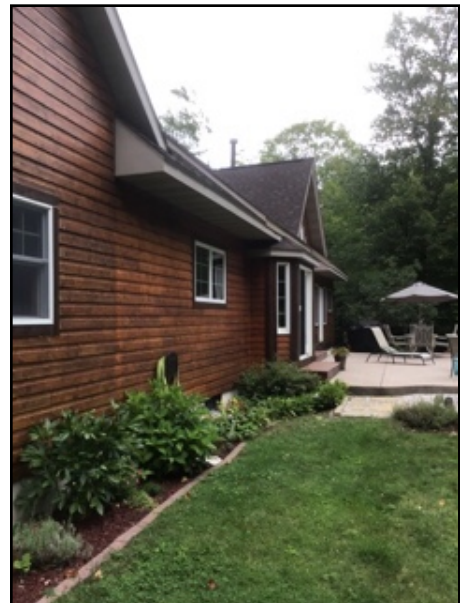
I always recommend full gutters systems on all homes. A proper system will take roof runoff away from the building, protect the base materials of the home, and keep the basement and crawl space areas dryer.

I do recommend the installation of a seamless gutters system,.

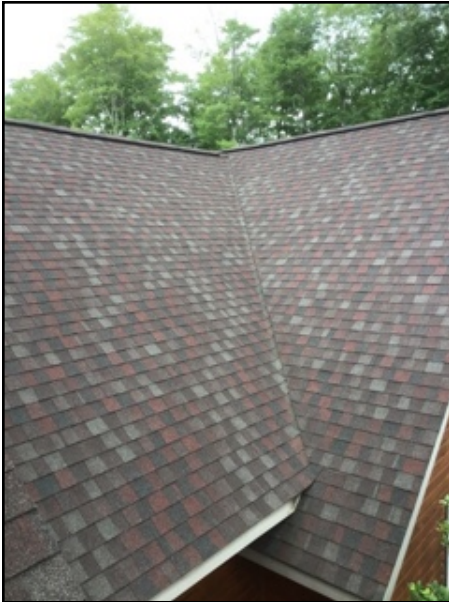
Figure 17-1

Newer roof covering was in good overall condition .

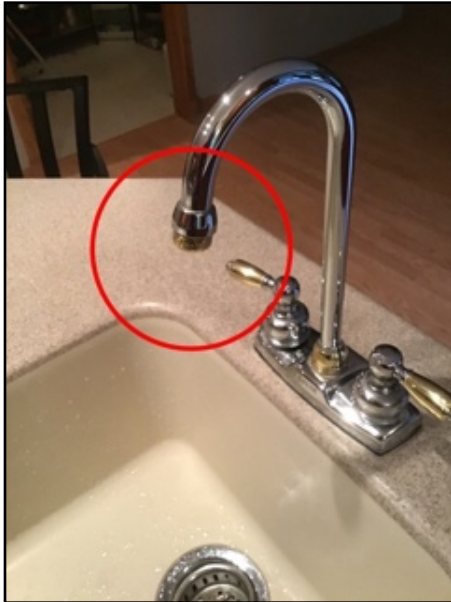
Figure 18-1

The airator at the prep sink was plugged and spraying, this will need to be removed and cleaned or replaced .

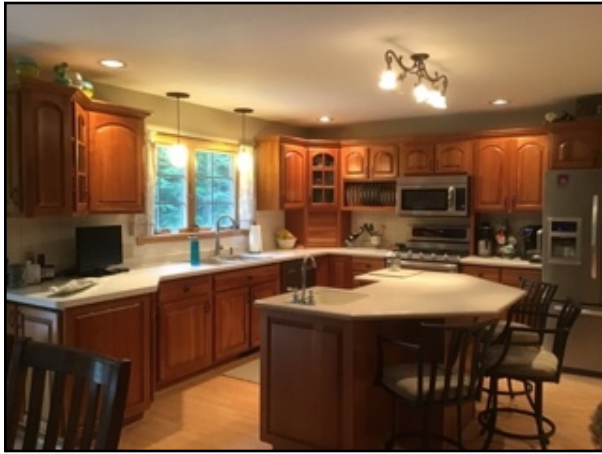
Figure 19-1

The kitchen area was found to be in very good general condition .

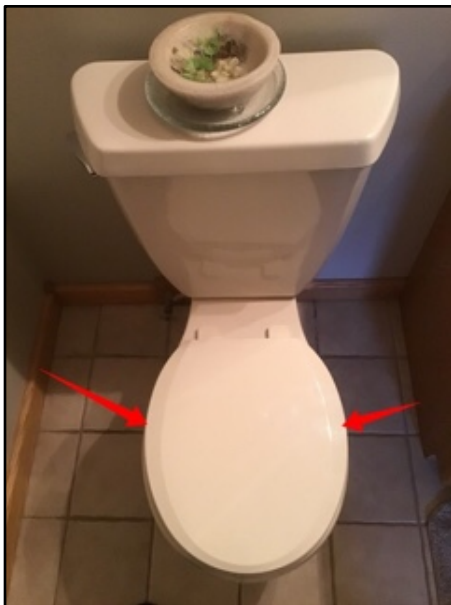
Figure 20-1

The toilet is loose at its base and needs to be tightened. Care needs to be taken to not crack the porcelain from over tightening of the two nuts used to secure the base.

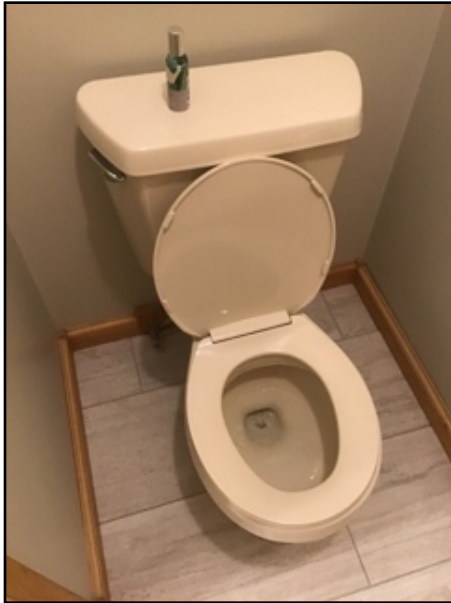
Figure 22-1

The toilet was also loose at its base and needs to be tightened. The same Care needs to be taken to not crack the porcelain from over tightening of the two nuts used to secure the base. Or the floor tile,

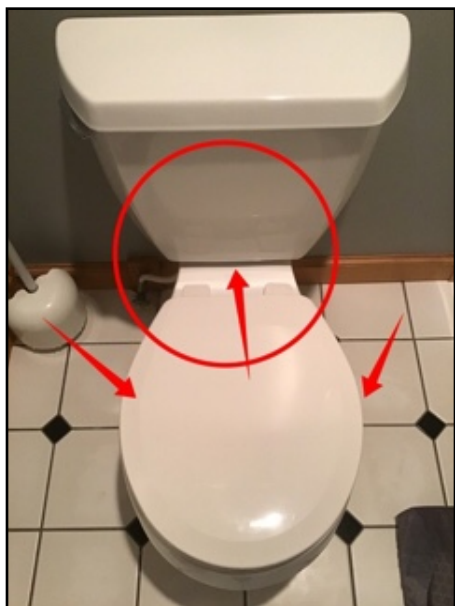
Figure 25-1

3 for 3, this toilet was also loose at its base and needs to be tightened.

The tank is also loose at the bowl connector, this was leaking, I turned the water off to this unit until repair is done to prevent any leaking or water damage, (none has occurred).

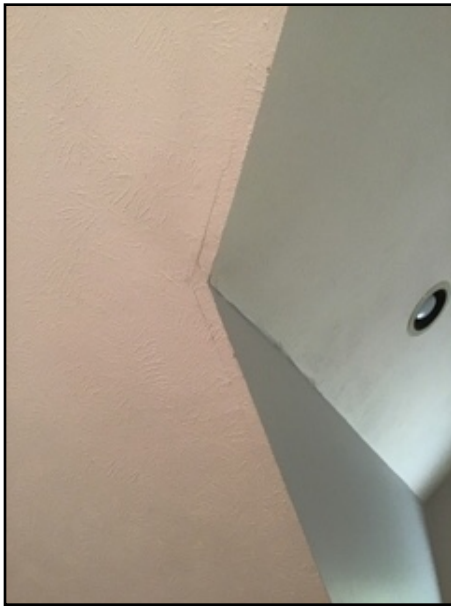
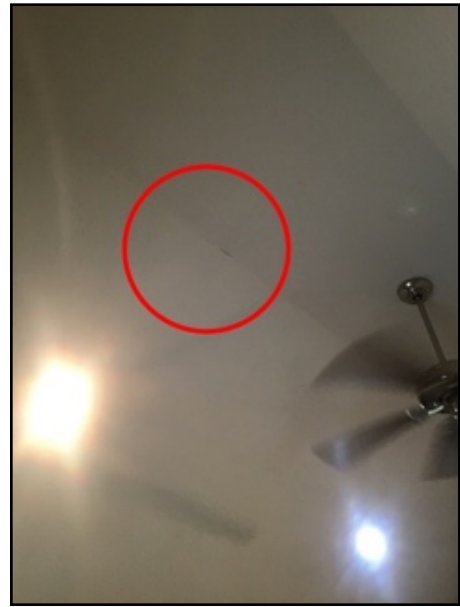
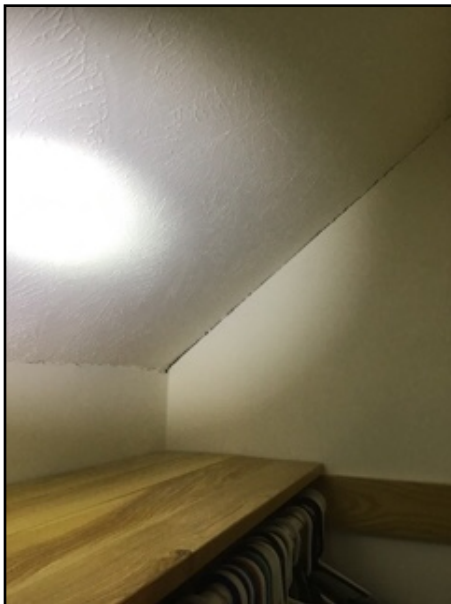
Photos show samples of edge and seam cracking, this is somewhat normal, no major crack or separation, but repair can be done at next painting .

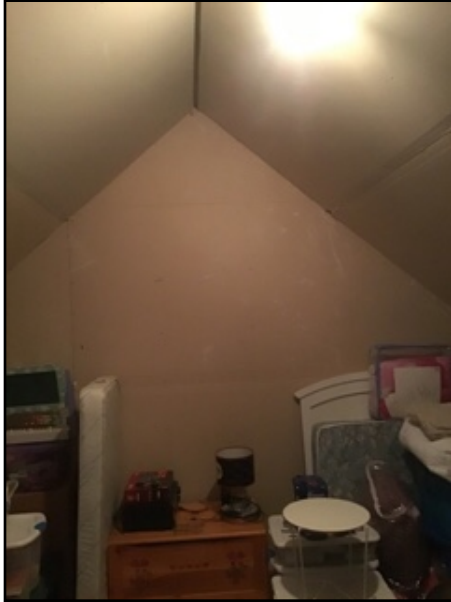
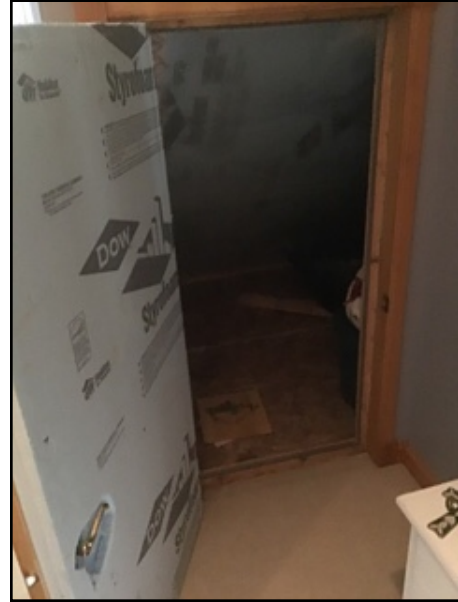
I would recommend having the drywall finished in the walk in area, this will improve energy efficiency,.

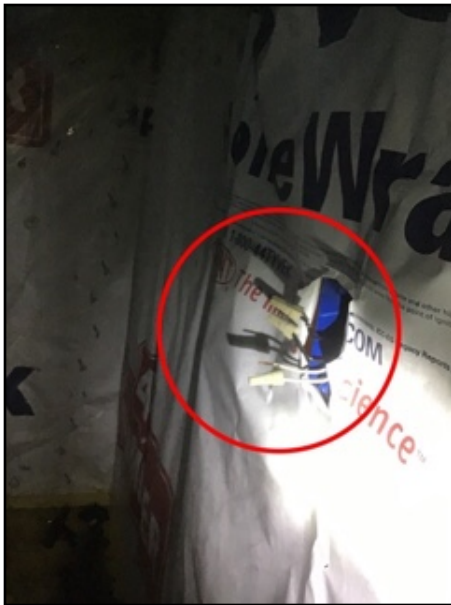
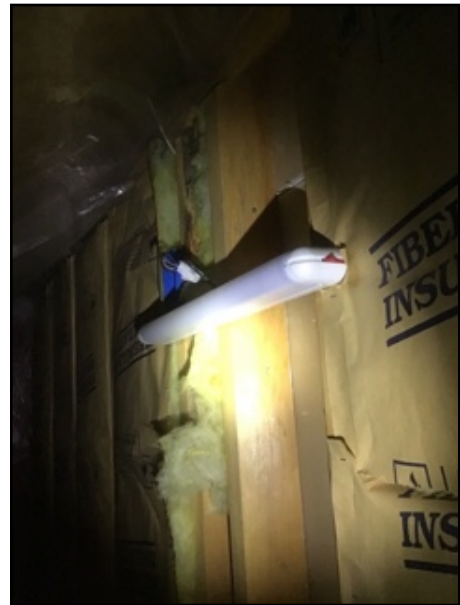
The light fixture and wiring was not finished in the attic areas, this should be done.

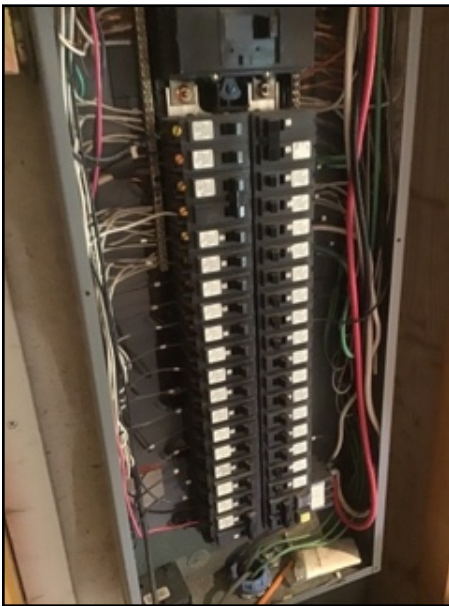
Figure 36-1

200 amp house panel .

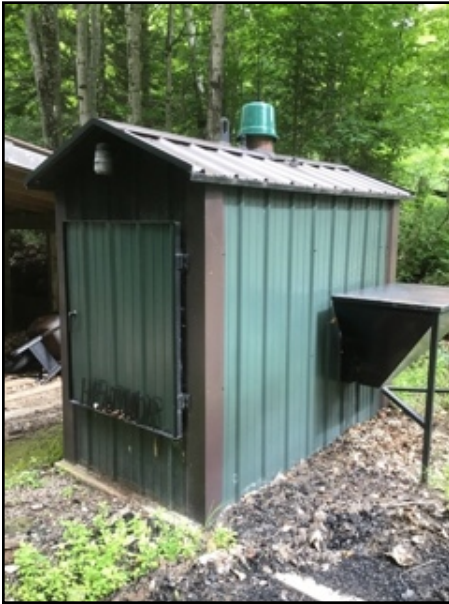
Figure 37-1

The wood boiler was not in use at time of inspection, this unit appears to be in good condition , NOTE: I recommend looking into having this system filled with an antifreeze type solution if you are not going to be attending it at all times during the winter,.

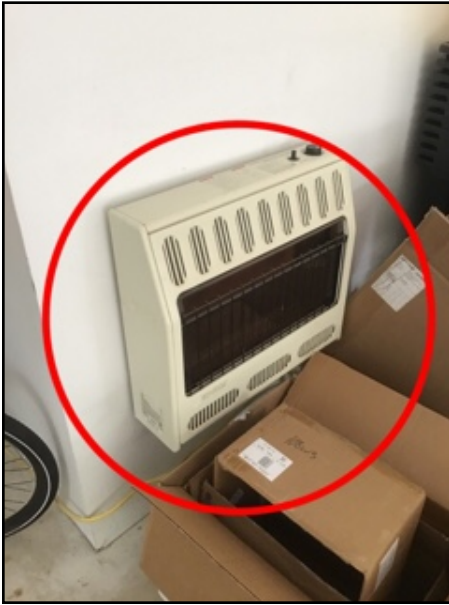
Figure 38-1

I do not recommend the use of any non vented gas space heating units, I recommend a vented type garage unit heater be installed if heating the garage is desired,.

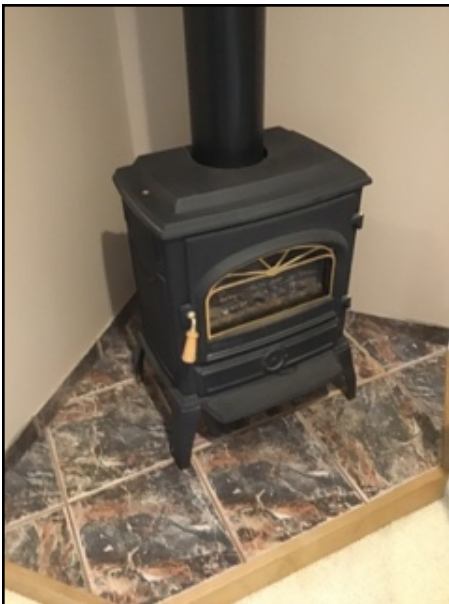
Figure 39-1

As noted this unit was not on for testing at time of inspection .

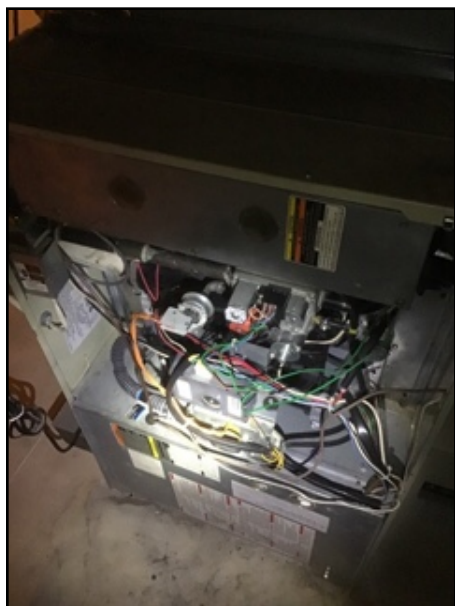
Figure 41-1

The original high efficiency gas furnace was operating as designed at inspection inspection .

Furnaces over 10 years old should be checked, cleaned and serviced yearly by a licensed contractor.

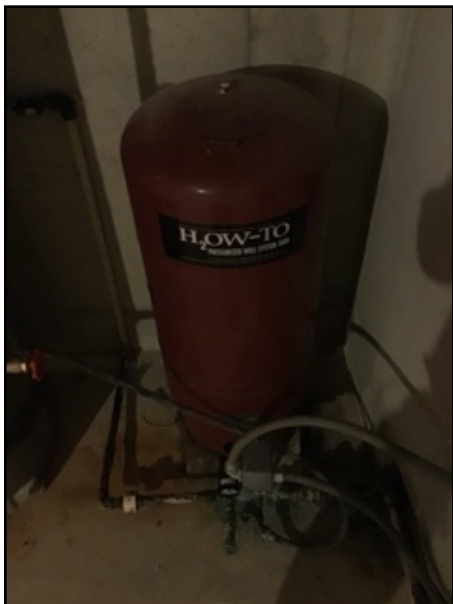
Figure 46-1

The well water supply system provided good flow, pressure and recovery during testing,.

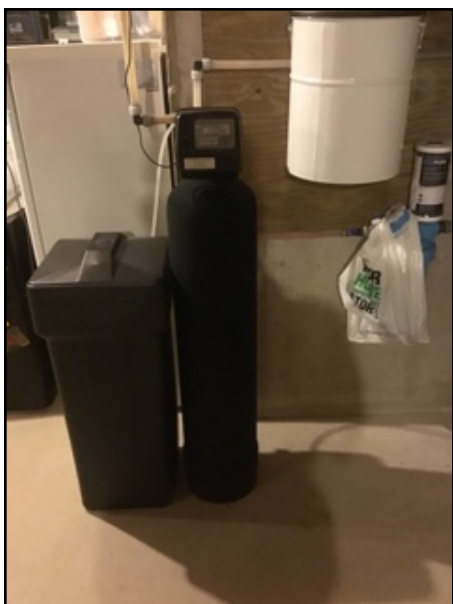
Figure 47-1

I always recommend contacting the system provider for any operating questions of water treatment systems, (contact information was on the equipment).

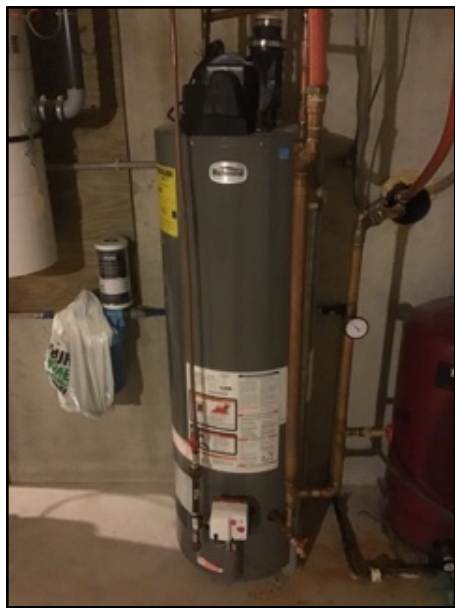
Figure 49-1

The power vent type water heater was operating as designed at inspection .

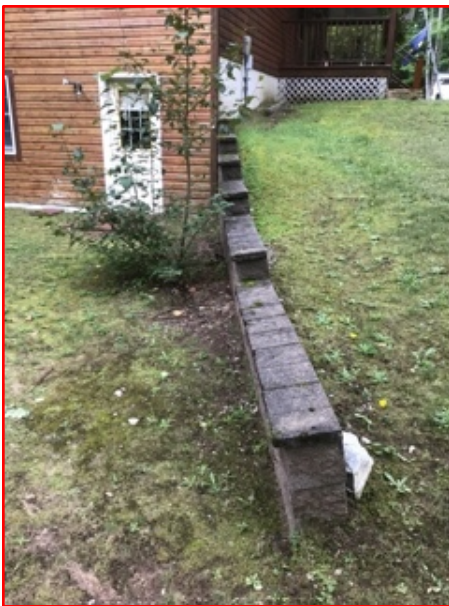
Figure 1-1

1) The front retaining wall is leaning from water pressure (roof runoff) this will need to be addressed at some point,.

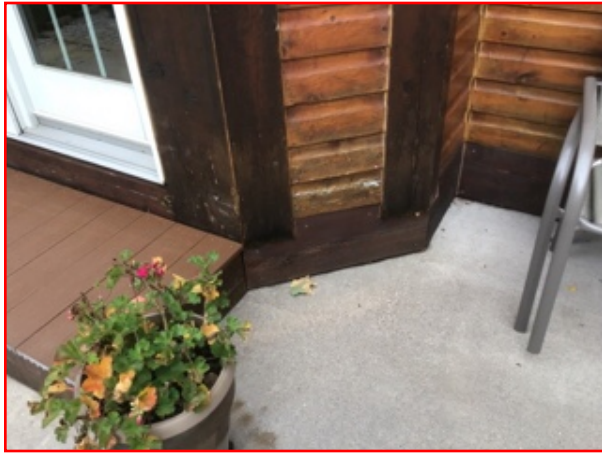
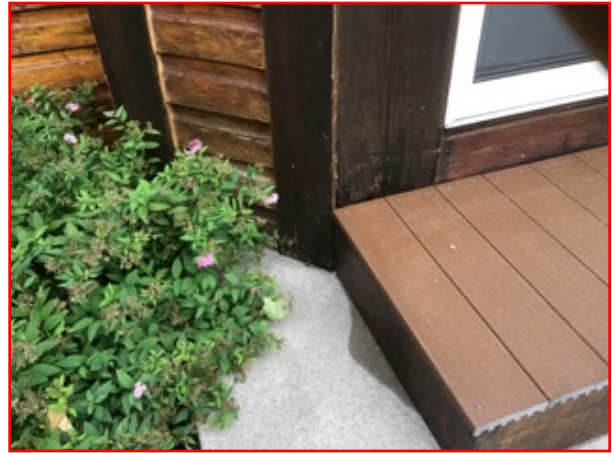
2) Also water splash from roof runoff is causing some water damage and deterioration along the back of the house along the base, (gutter system would prevent this).

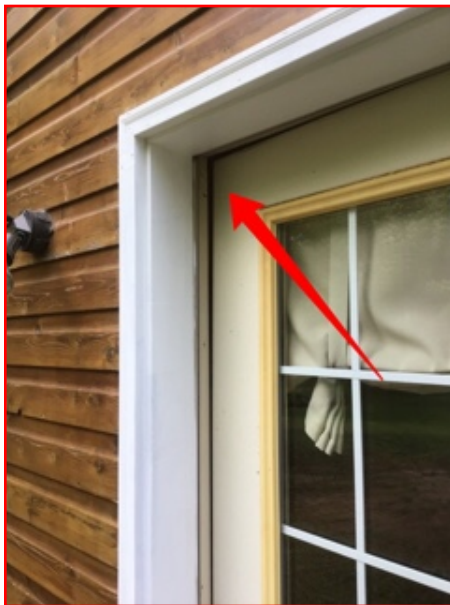
Figure 5-1

3) The basement entry door is warped causing poor sealing, this door will need replacement to remedy this,.

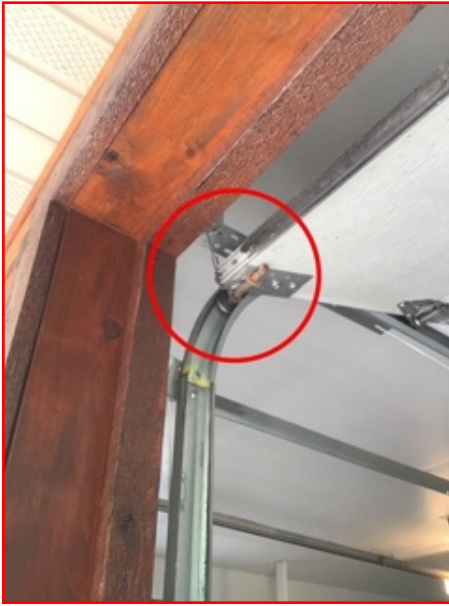
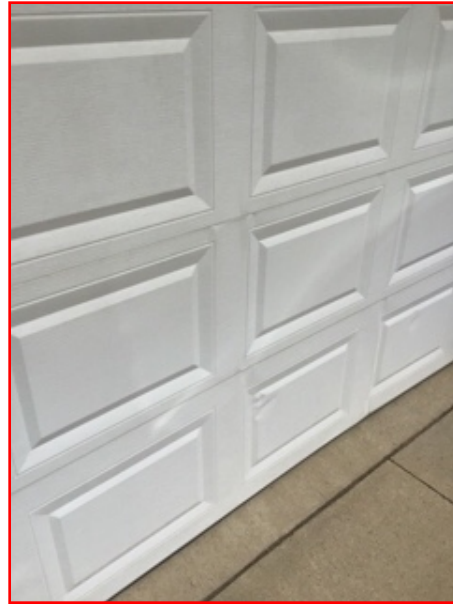
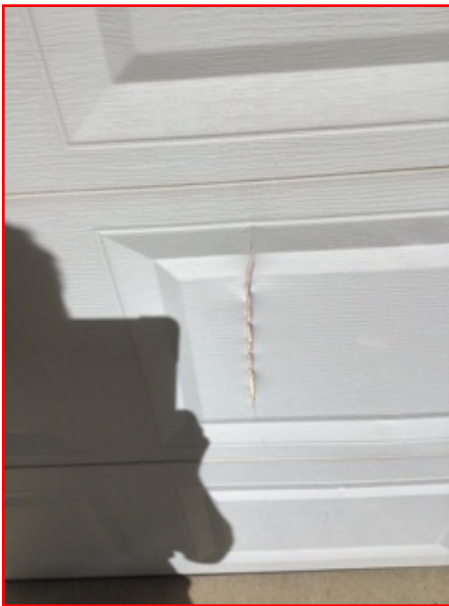
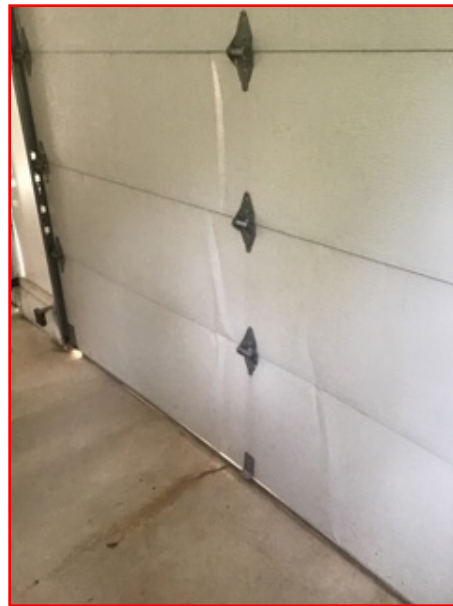
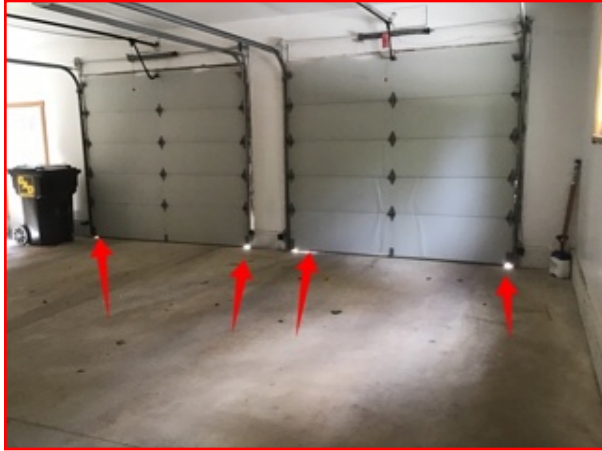
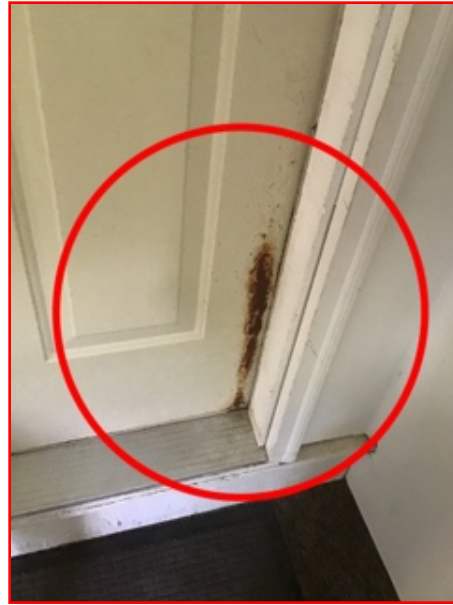
4) The garage door seal is damaged. (at both doors) These can be replaced. Also both doors do have some damage, noted in the photos, this damage is not effecting the operation, also the garage entry door has some pet damage , this can be repaired by sanding and re painting

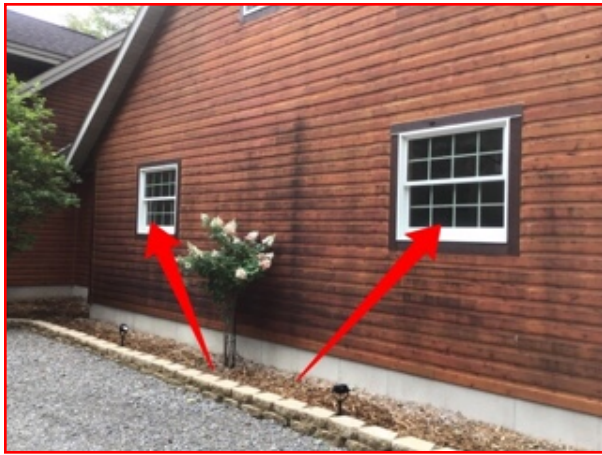
Figure 10-1

5) North side garage windows were missing the screens, ask about this? (one was found in the storage area).

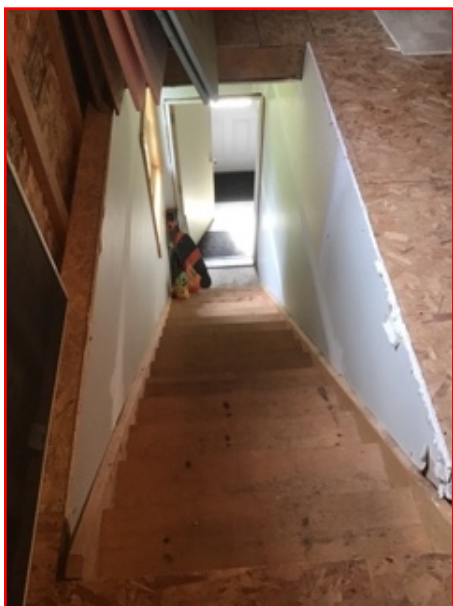
Figure 11-1

6) Safety hand railings are recommended at all stairways with 3 treads or more, also your insurance providers may require them. this safety item was missing at the garage stairway,

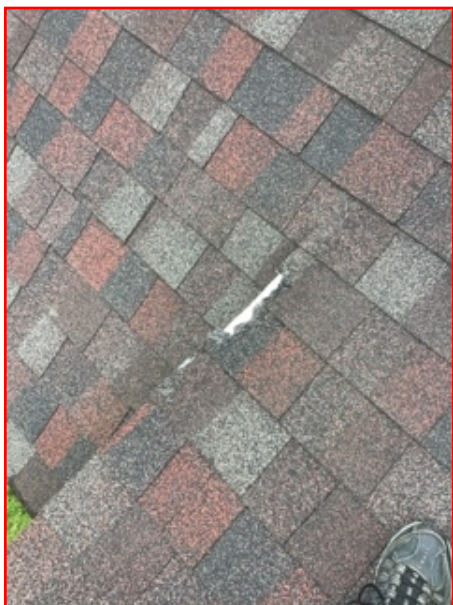
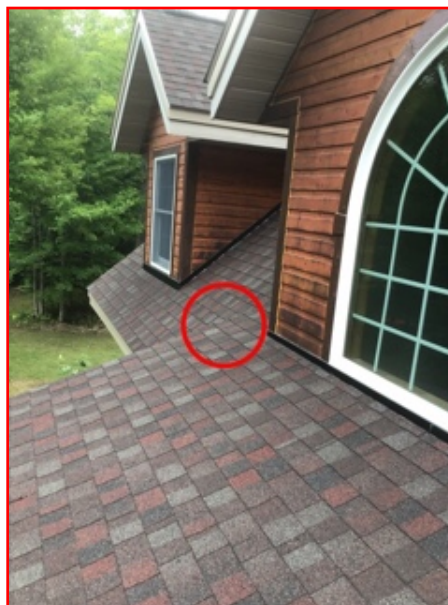
7) One edge section of the front porch roof had some minor damage, (appears to be from snow removal , photo 2 shows location, (noted , but repair is not needed at this time).

8) Care must be used when removing roof area snow, it is best to hire a professional,.

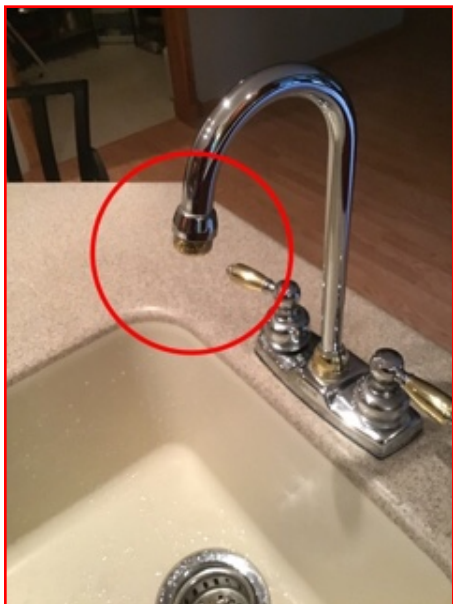
Figure 18-1

9) The airator at the prep sink was plugged and spraying, this will need to be removed and cleaned or replaced .

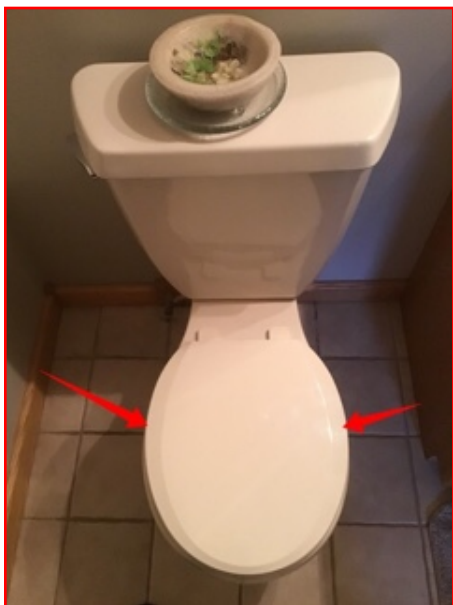
Figure 20-1

10) The toilet is loose at its base and needs to be tightened. Care needs to be taken to not crack the porcelain from over tightening of the two nuts used to secure the base.

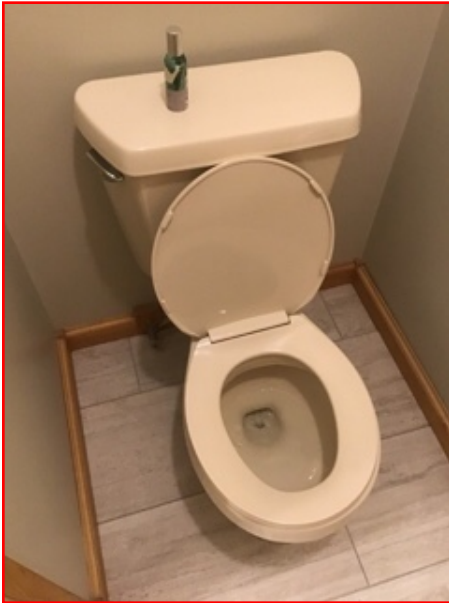
Figure 22-1

11) The toilet was also loose at its base and needs to be tightened. The same Care needs to be taken to not crack the porcelain from over tightening of the two nuts used to secure the base. Or the floor tile,

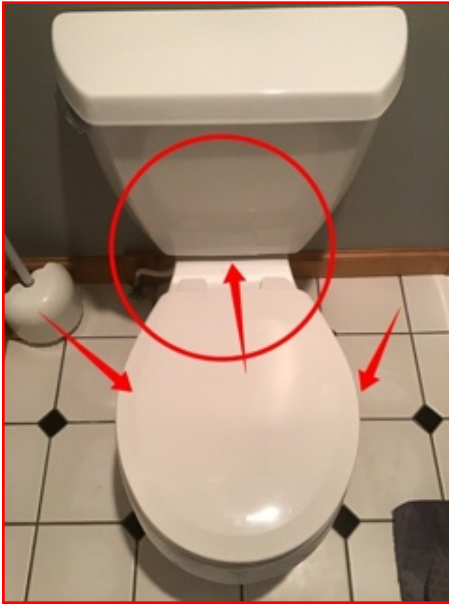
Figure 25-1

12) 3 for 3, this toilet was also loose at its base and needs to be tightened.

13) The tank is also loose at the bowl connector, this was leaking, I turned the water off to this unit until repair is done to prevent any leaking or water damage, (none has occurred).

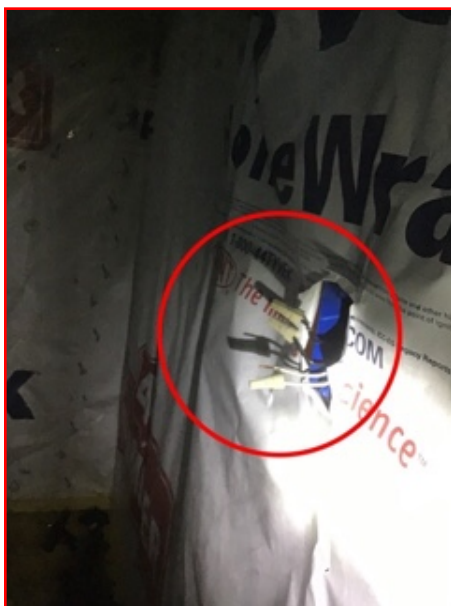
Figure 34-1

15) The light fixture and wiring was not finished in the attic areas, this should be done.

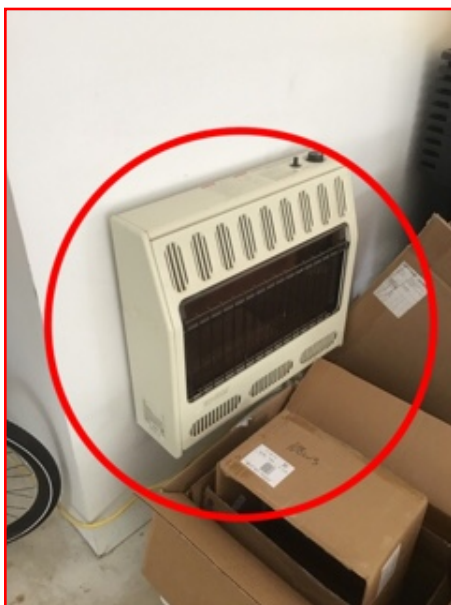
Figure 38-1

16) I do not recommend the use of any non vented gas space heating units, I recommend a vented type garage unit heater be installed if heating the garage is desired,.
