**HOME
EVALUATION
SERVICES**

Home Inspection Report

Sample Report

Inspected on Thu, Sep 3 2020 at 2:00 PM

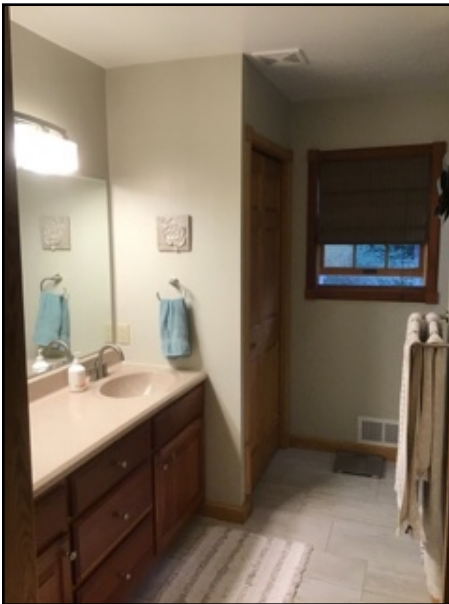
Figure 23-1

The master bathroom is #2.

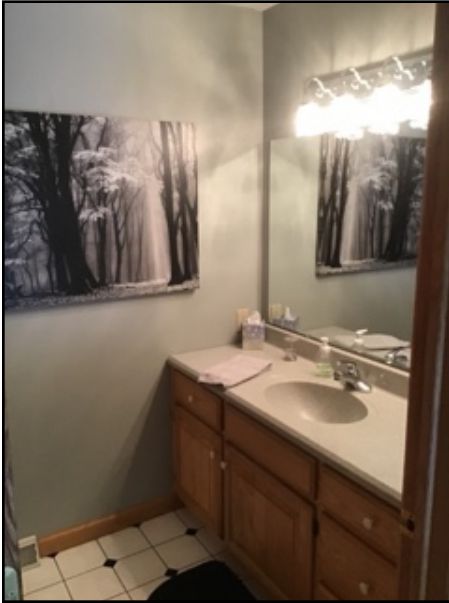
Figure 26-1

The upper bathroom is #3.

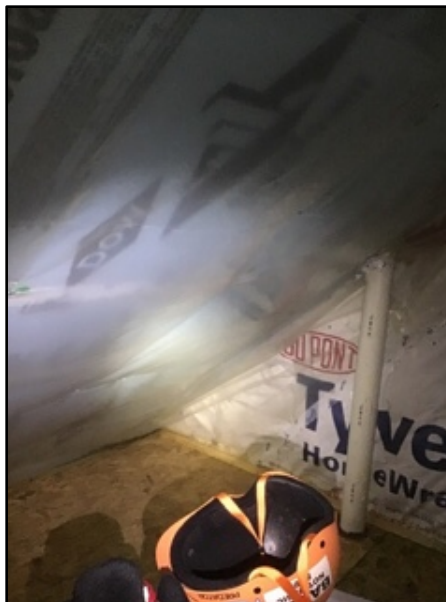
Knee wall acces along with one walk in area

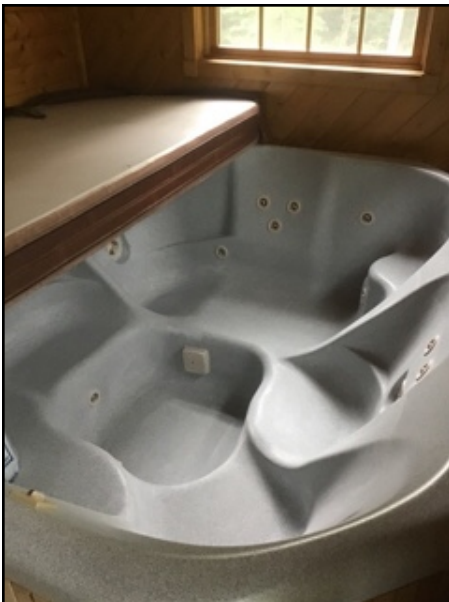
Figure 45-1

The hot tub was not filled or in use at time of inspection , if this unit is important to you, ask that it be filled and operating for your final walk through,.
